TECHNICAL NOTE 4263

EFFECT OF PRIOR AIR FORCE OVERTEMPERATURE
OPERATION ON LIFE OF J47 BUCKETS EVALUATED
IN A SEA-LEVEL CYCLIC ENGINE TEST

By Robert A. Signorelli, James R. Johnston, and Floyd B. Garrett

Lewis Flight Propulsion Laboratory
Cleveland, Ohio

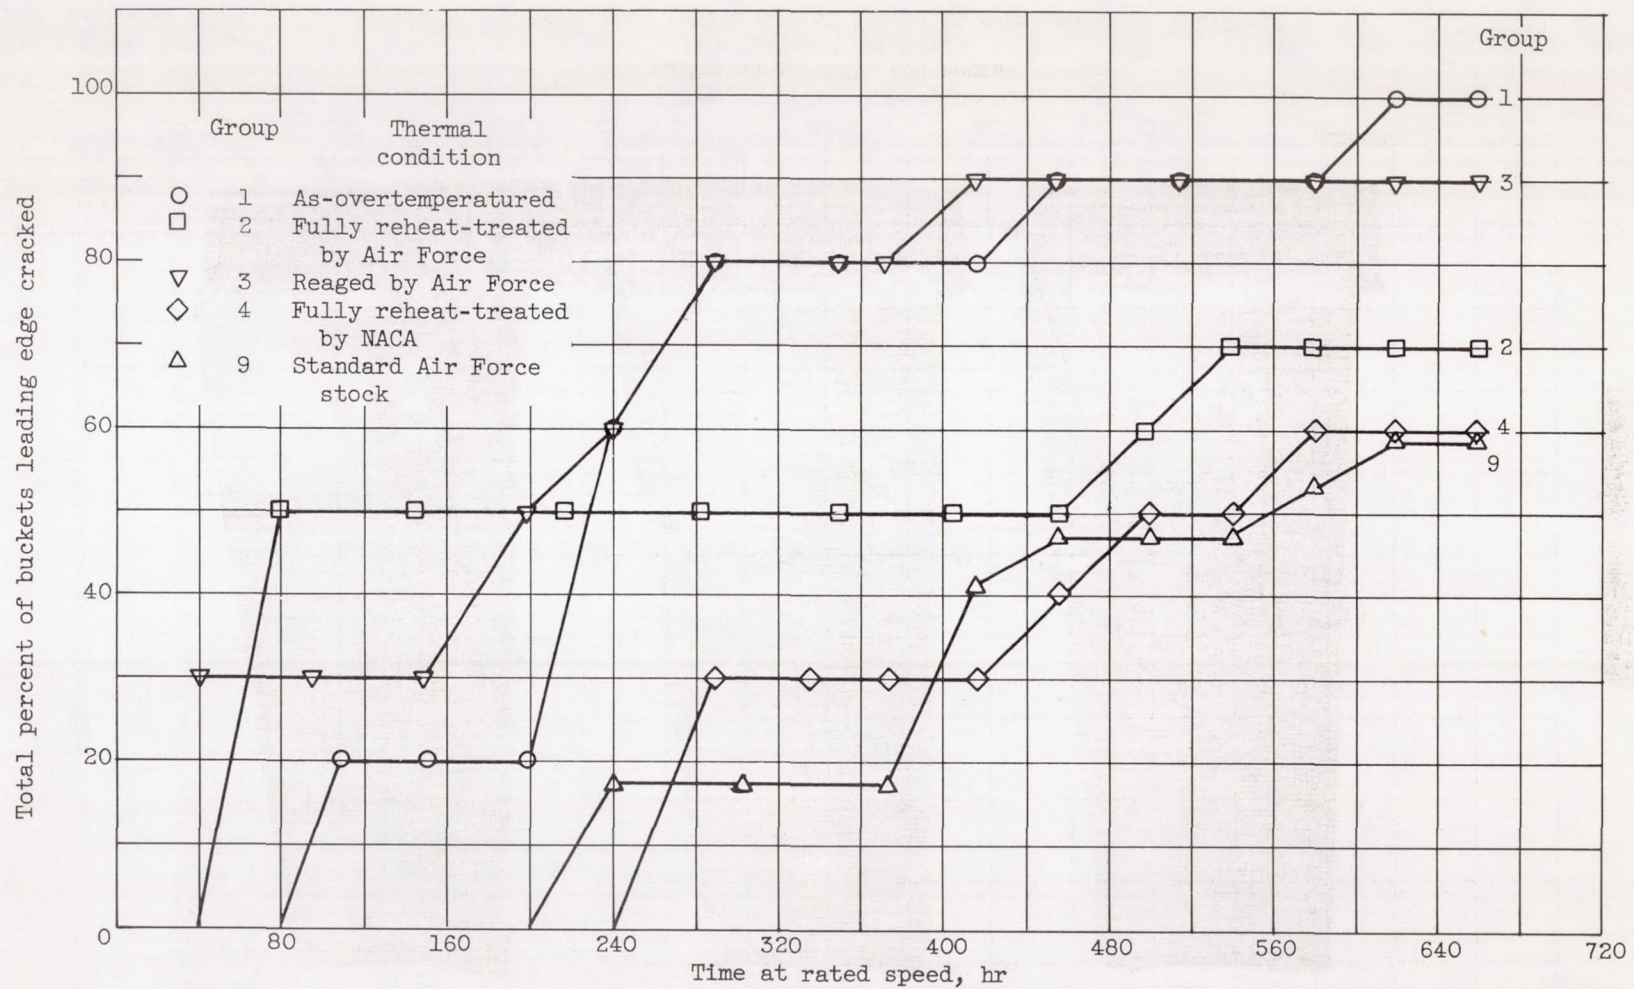
(a) Engine A buckets.

Leading-edge cracking. - The leading-edge cracking data have been plotted in figure 5. Figure 5(a) shows the cumulative percentages of buckets with leading-edge cracks for each of the groups of buckets originally obtained from engine A (groups 1 to 4). The percentages of buckets with leading-edge cracks is plotted against engine test time. Figure 5(b) shows similar data for the groups of buckets originally obtained from engine B (groups 5 to 8). For comparison, both figures show leading-edge cracking data for the standard Air Force stock buckets (group 9). Buckets of the as-overtempered groups (1 and 5) and the overtempered and reaged groups (3 and 7) developed leading-edge cracks more readily than buckets in the other groups. After 240 hours of operation, leading-edge cracks were present in 60 percent of the buckets of groups 1 and 3 and in 40 and 70 percent, respectively, of buckets of groups 5 and 7 (fig. 5). Only 18 percent of the standard Air Force stock buckets (group 9) had leading-edge cracks after 240 hours. However, the group 9 buckets were new when they were installed in the engine test, while all other groups had a prior service life. The service life of the buckets is not known, but the flight time on the engines was 209 and 242 hours, respectively, for engines A and B. Perhaps the prior service life, rather than overtemperature, accounts for the larger number of leading-edge cracked buckets.

In this investigation, resistance to leading-edge cracking appears to have been increased by the full standard heat treatment of as-overtemperated buckets. As may be noted in figure 5, groups 2, 4, 6, and 8 had lower incidences of leading-edge cracking than did the as-overtemperated groups, 1 and 5. In fact, the incidence of leading-edge cracking of the fully reheat-treated groups was about the same as the new standard-group buckets.

Figure 5. - Leading-edge cracking with time at rated speed.

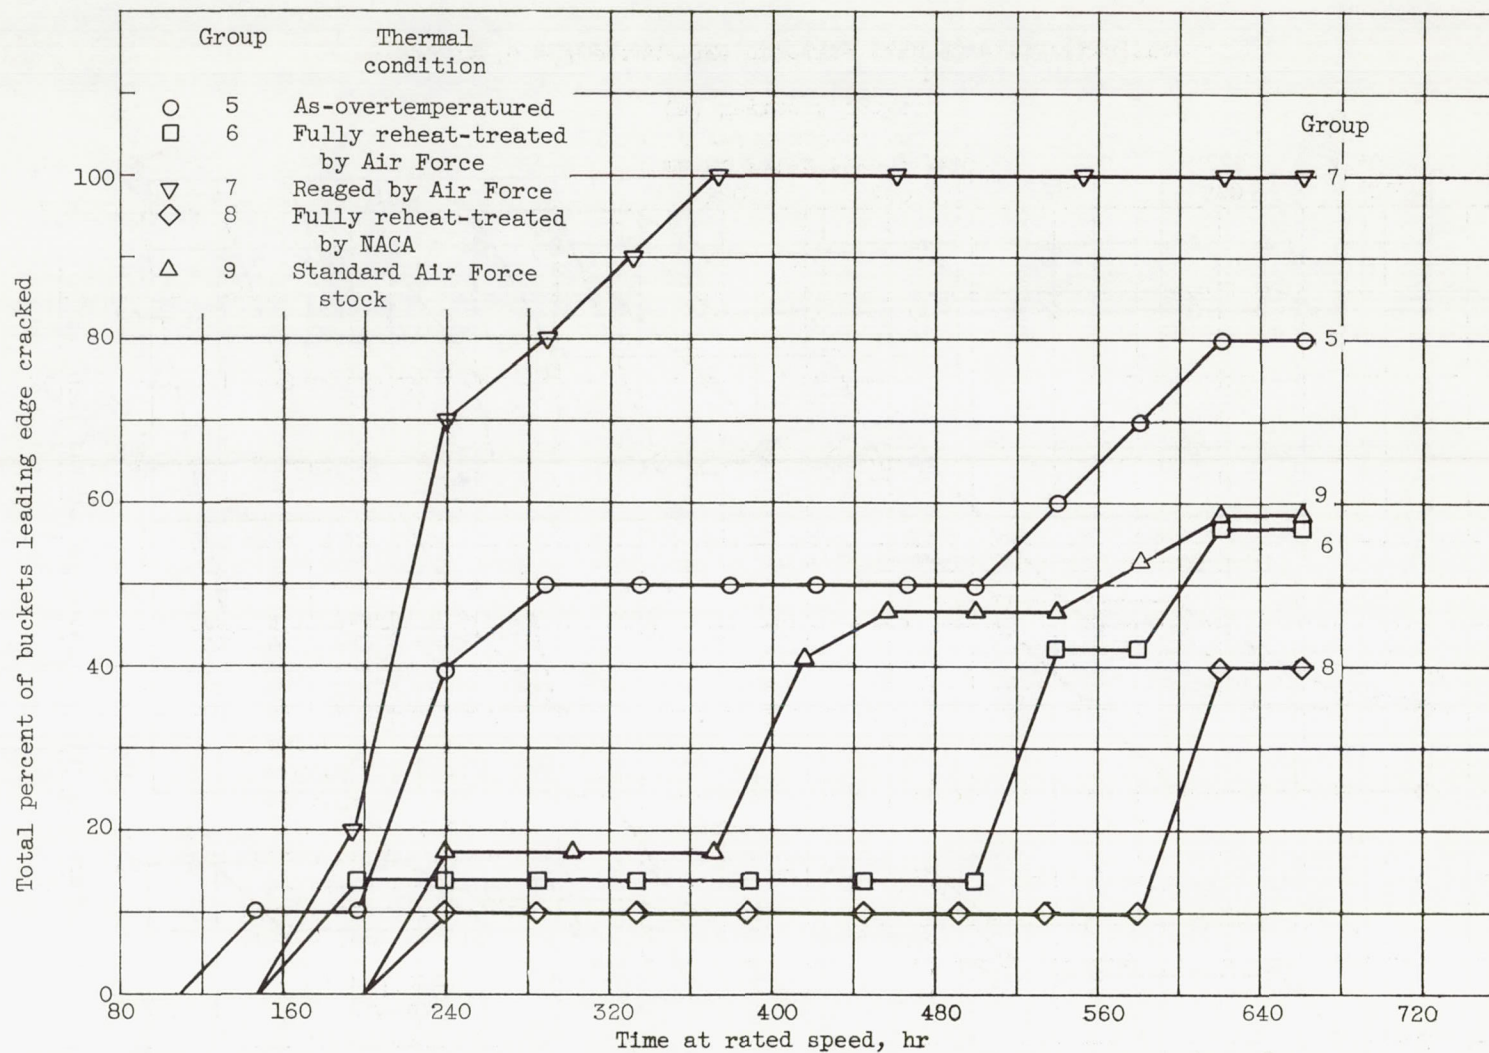
(b) Engine B buckets.

Figure 5. - Concluded. Leading-edge cracking with time at rated speed.

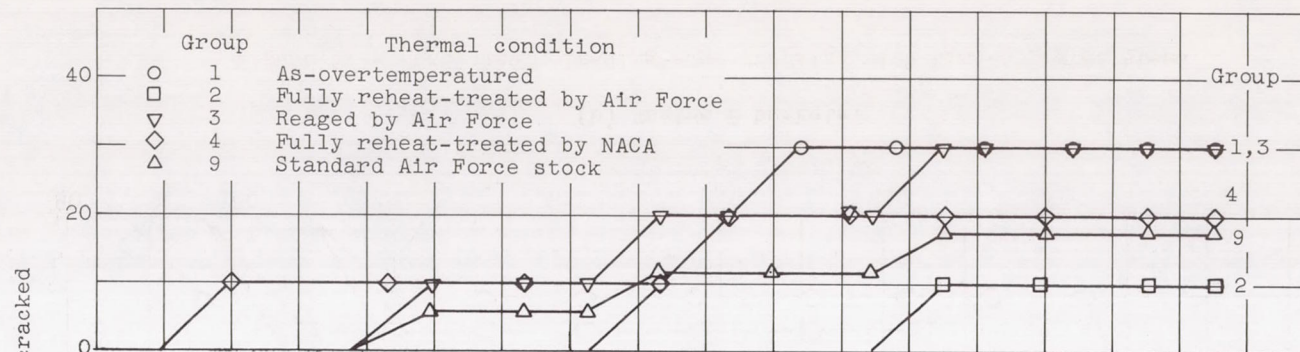
(a) Engine A buckets.

Radial-tip cracking. - The incidence of radial-tip cracking is shown in figure 6. The difference between the bucket groups in the incidence of radial-tip cracking was less than that obtained for leading-edge

4567
cracking. The data in figure 6(a) show little difference in incidence of radial-tip cracking among bucket groups from engine A. Upon first examination of figure 6(b), however, there might appear to be a significant difference in the incidence of radial-tip cracking among bucket groups from engine B. Particularly, it would appear that the group given a full reheat treatment by the Air Force (group 6) has a greater incidence of tip cracking than does the group given the full reheat treatment by the NACA (group 8). The noted difference is not believed to be significant, however, since, in the case of the similar groups of engine A (groups 2 and 4) no detrimental effect of the Air Force treatment was noted; and, even in the case of the previously discussed leading-edge cracking (fig. 5(b)), the effect of the full reheat treatment was about the same, whether given by the Air Force (group 6) or NACA (group 8).

Figure 6. - Radial-tip cracking with time at rated speed.

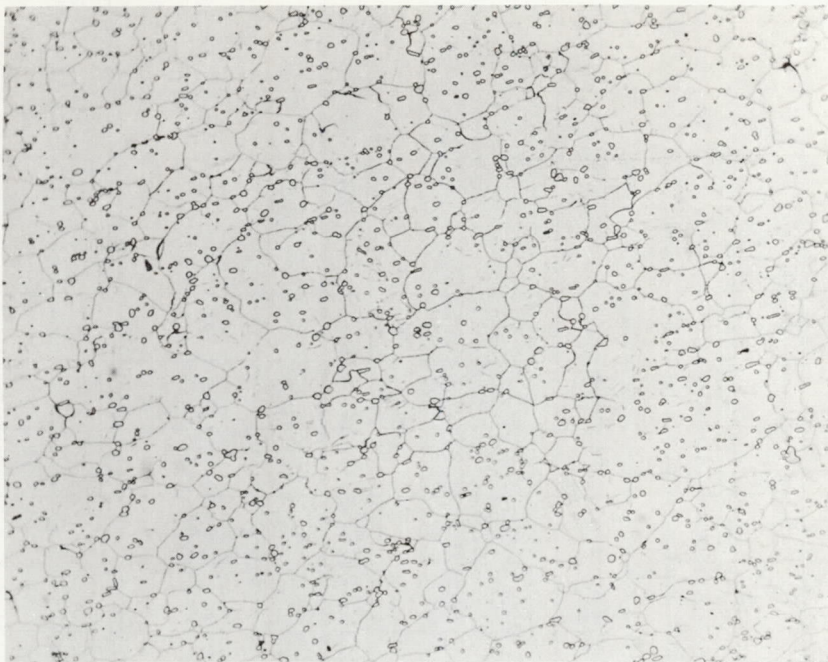
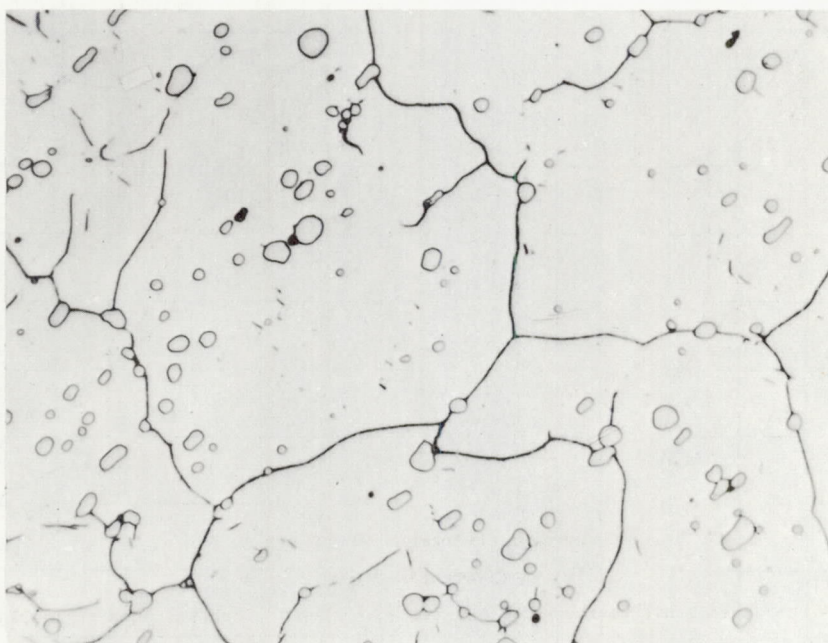
(a) Group 9, standard S-816.

Untested buckets. - Typical microstructures of bucket from the overtemperated groups and the standard group before engine testing are shown in figure 7. The standard heat-treated S-816 alloy bucket (fig. 7(a)) has large, stable, columbium-tantalum carbide precipitates in the matrix and continuous grain-boundary precipitation. The as-overtemperated bucket microstructures (groups 1 and 5) in figure 7(b) show agglomeration and spheroidization of grain-boundary precipitates that have been associated with overtemperature, as described earlier. Although the photomicrographs of the specific buckets of figure 7(b) indicate slightly more hyphenation of grain-boundary precipitation for group 1 than for group 5, examination of microstructures of a number of buckets from groups 1 and 5 indicates that the degree of hyphenation is about equivalent for the two groups of buckets. Buckets of groups 2, 4, 6, and 8, overtemperated and reheat-treated, are shown in figures 7(c) and (e). The microstructures are typical of S-816 in the normal heat-treated condition. The microstructural evidence associated with overtemperature is no longer visible. The overtemperated and reaged buckets of groups 3 and 7 are shown by the microstructures in figure 7(d). The precipitation

Figure 7. - Microstructures of untested buckets.
Etchant, aqua regia plus glycerol.

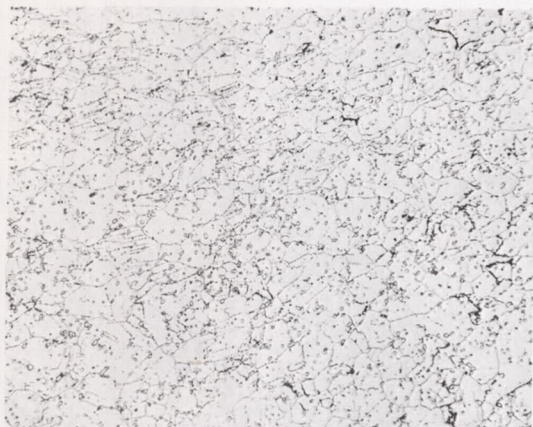
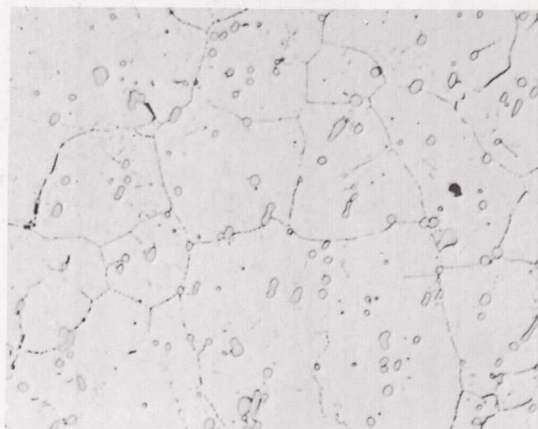
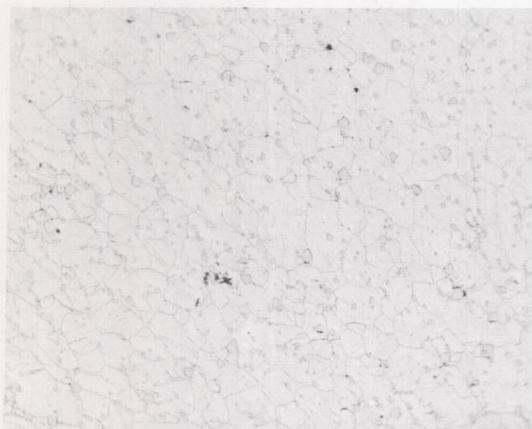
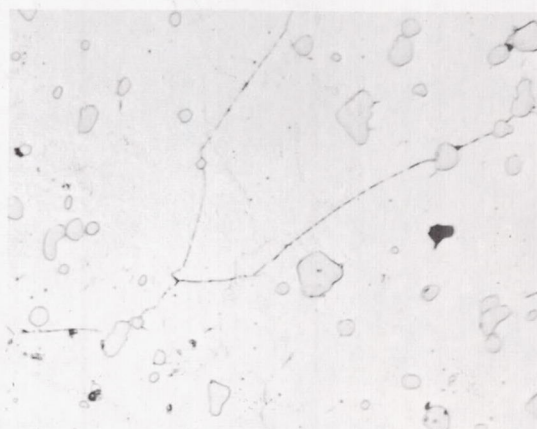
Group 1, overtemperated in engine A

Group 5, overtemperated in engine B

Figure 7. - Continued. Microstructures of untested buckets. Etchant, aqua regia plus glycerol.

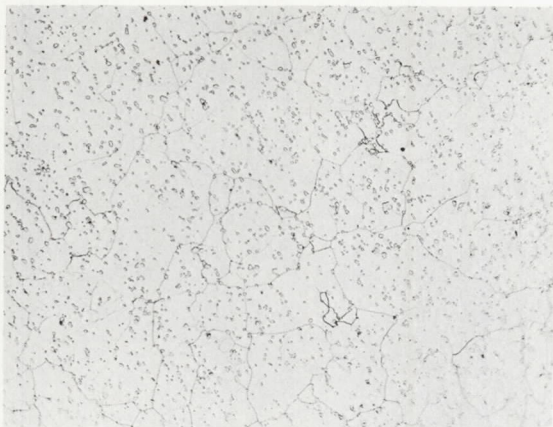
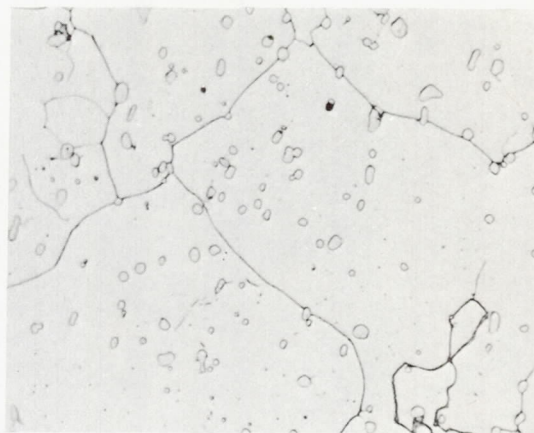
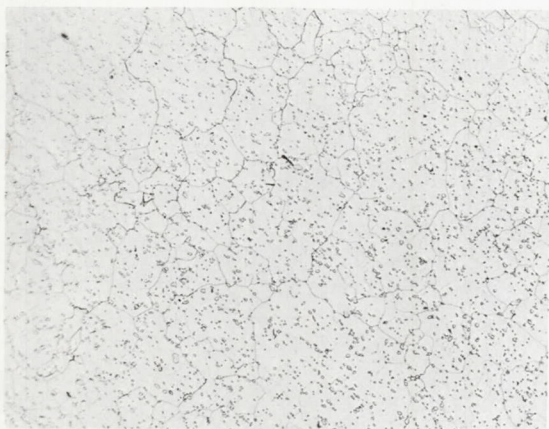
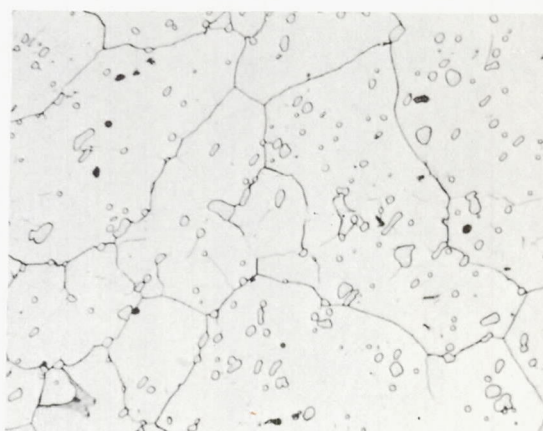
Group 2, overtemperated in engine A and reheat-treated

Group 6, overtemperated in engine B and reheat-treated

Figure 7. - Continued. Microstructures of untested buckets. Etchant, aqua regia plus glycerol.

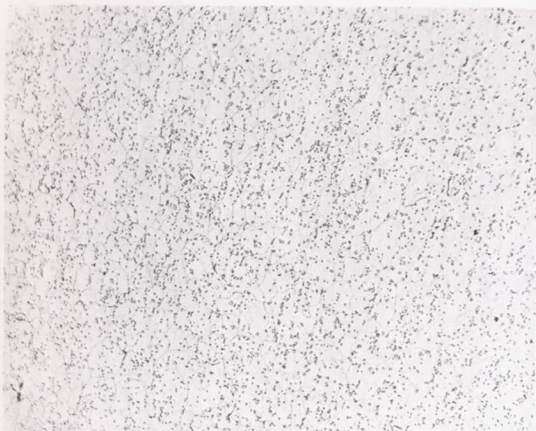
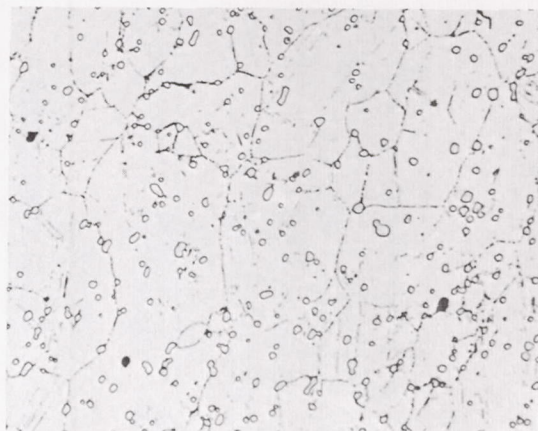
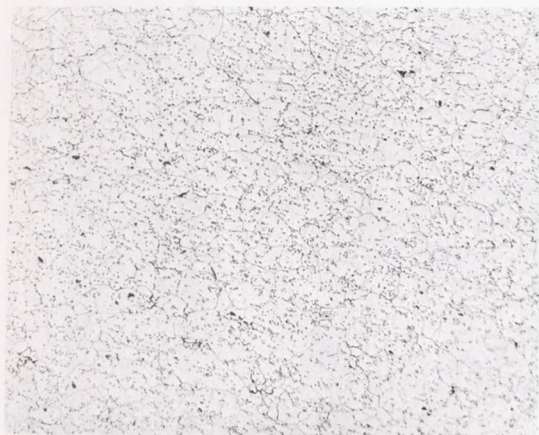
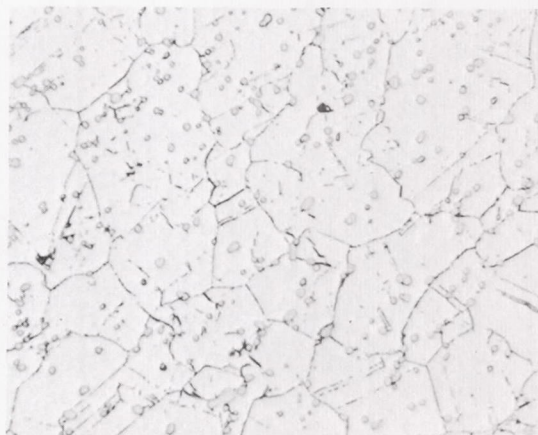
Group 3, overtemperated in engine A and reaged.

Group 7, overtemperated in engine B and reaged

Figure 7. - Continued. Microstructures of untested buckets. Etchant, aqua regia plus glycerol.

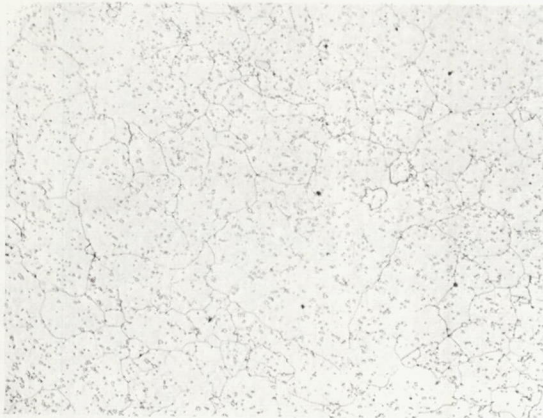
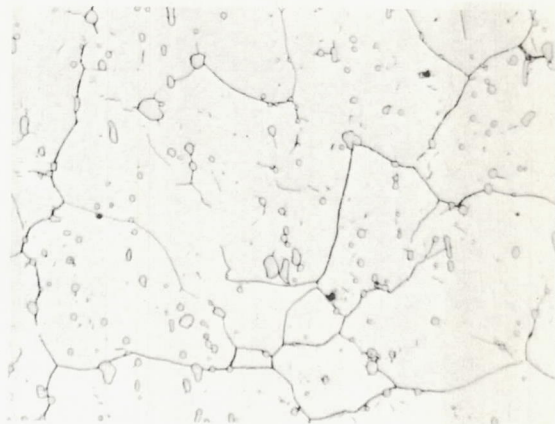
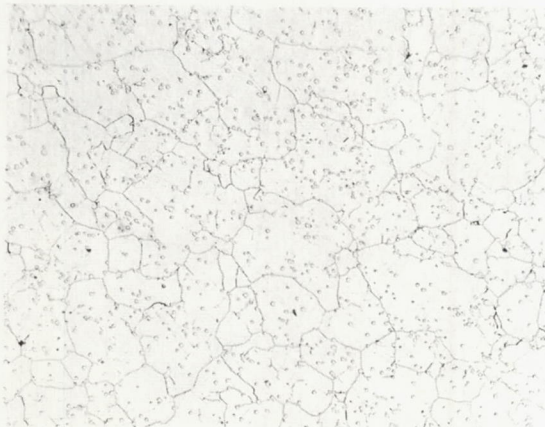
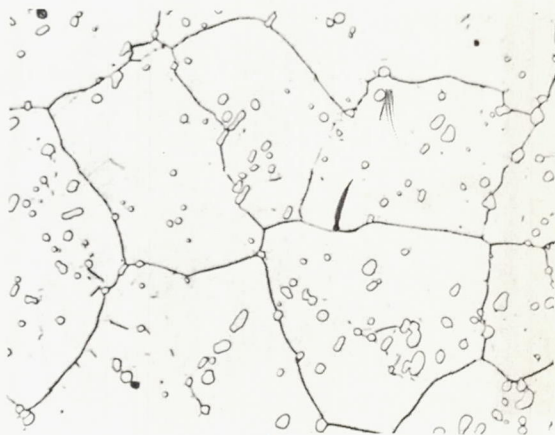
Group 4, overtemperated in engine A and reheat-treated

Group 8, overtemperated in engine B and reheat-treated

Figure 7. - Concluded. Microstructures of untested buckets. Etchant, aqua regia plus glycerol.

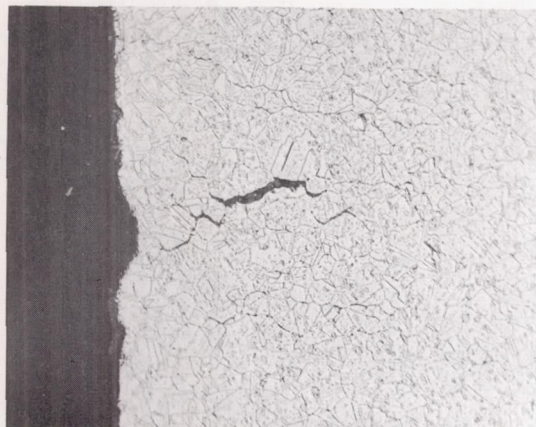
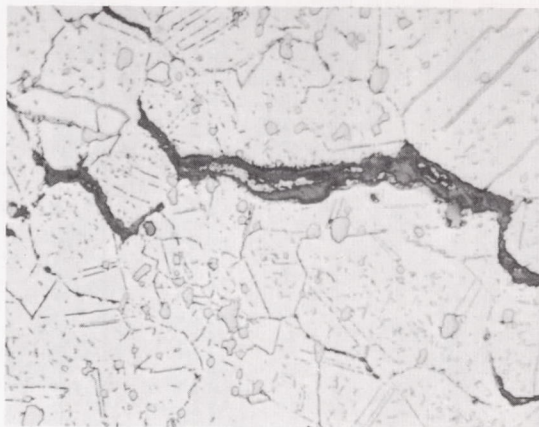
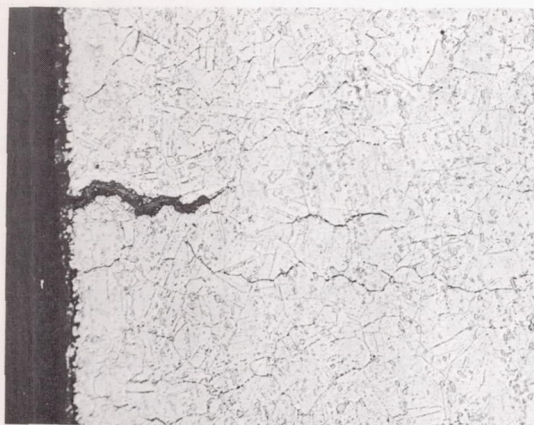
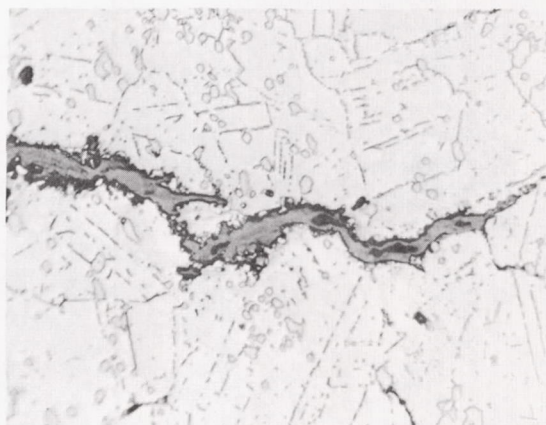
Engine-tested buckets. - Microstructural studies of buckets after engine testing are presented in figure 8. Buckets of all groups showed an advanced stage of aging, with little or no microstructural difference among groups. Several small leading-edge cracks are also shown in the photomicrographs. Small cracks with less oxidation than the larger cracks were photographed because oxidation obscured the surfaces of larger cracks and hampered classification of cracks as intergranular or transgranular.

Group 1, overtemperatured in engine A

Group 5, overtemperatured in engine B

Figure 8. - Microstructures after engine test.

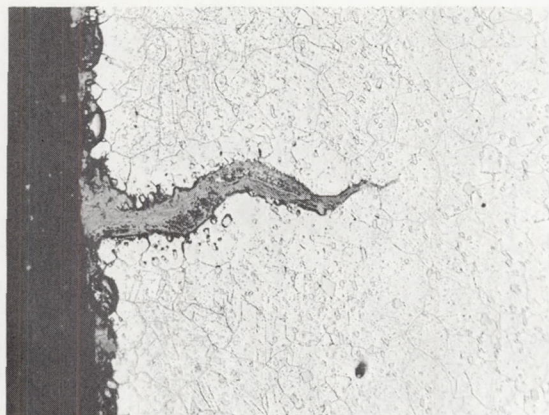
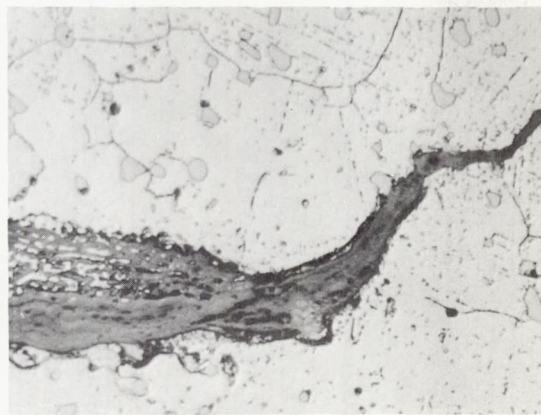
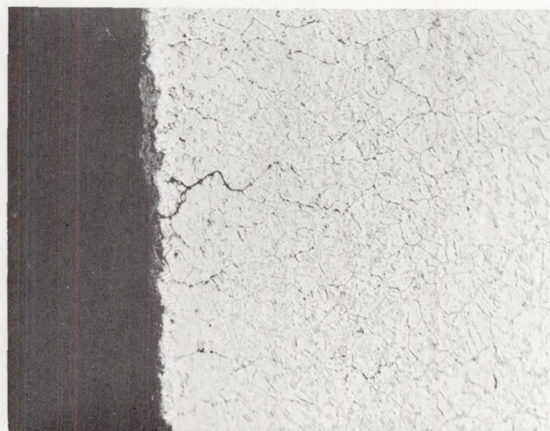
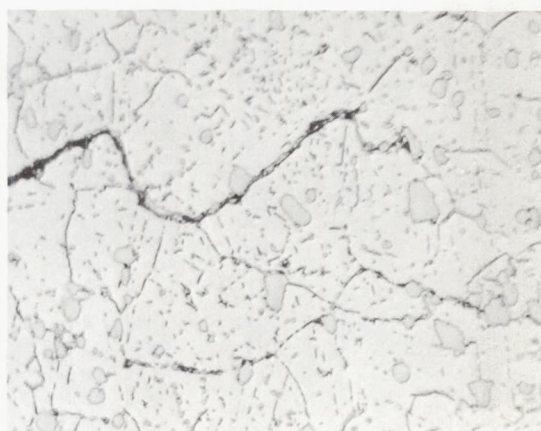
Group 2, overtemperated in engine A and reheat-treated

Group 6, overtemperated in engine B and reheat-treated
(b) Buckets overtemperated and reheat-treated by Air Force.

Figure 8. - Continued. Microstructures after engine test.

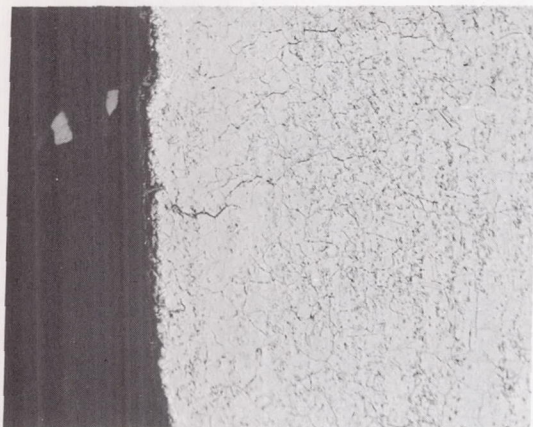
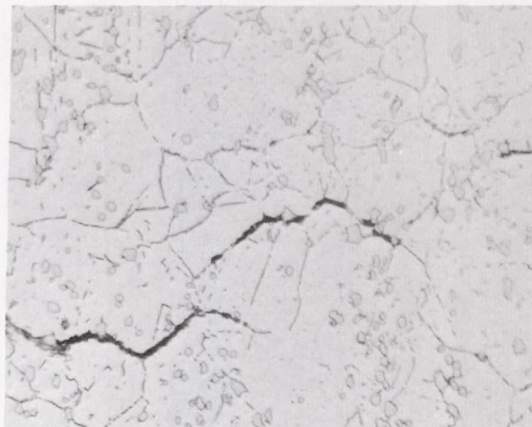
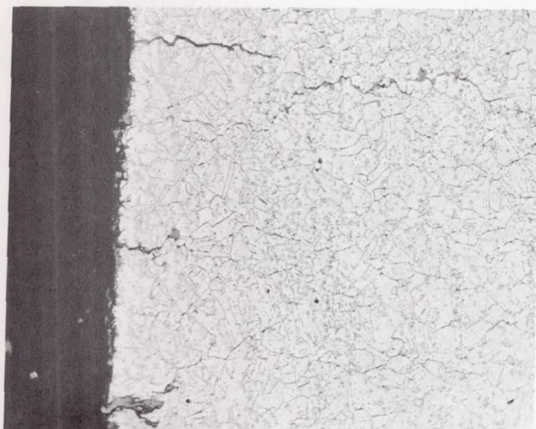
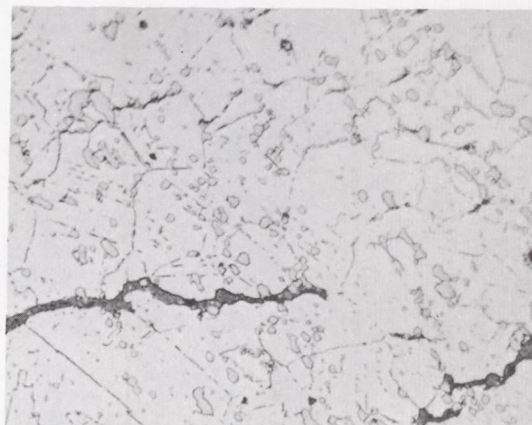
Group 3, overheated in engine A and reaged

Group 7, overheated in engine B and reaged

Figure 8. - Continued. Microstructures after engine test.

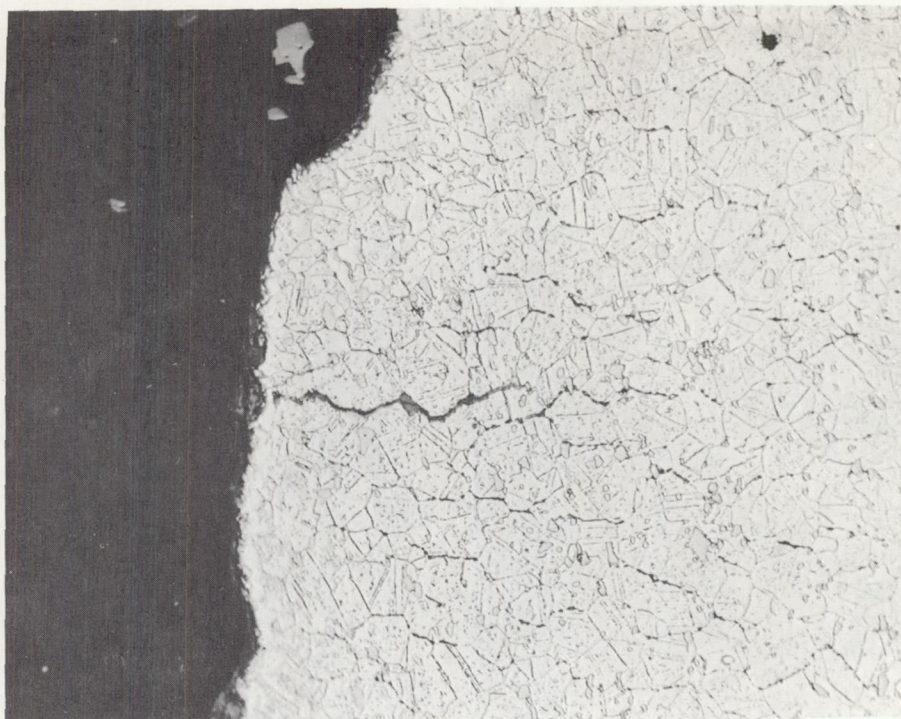
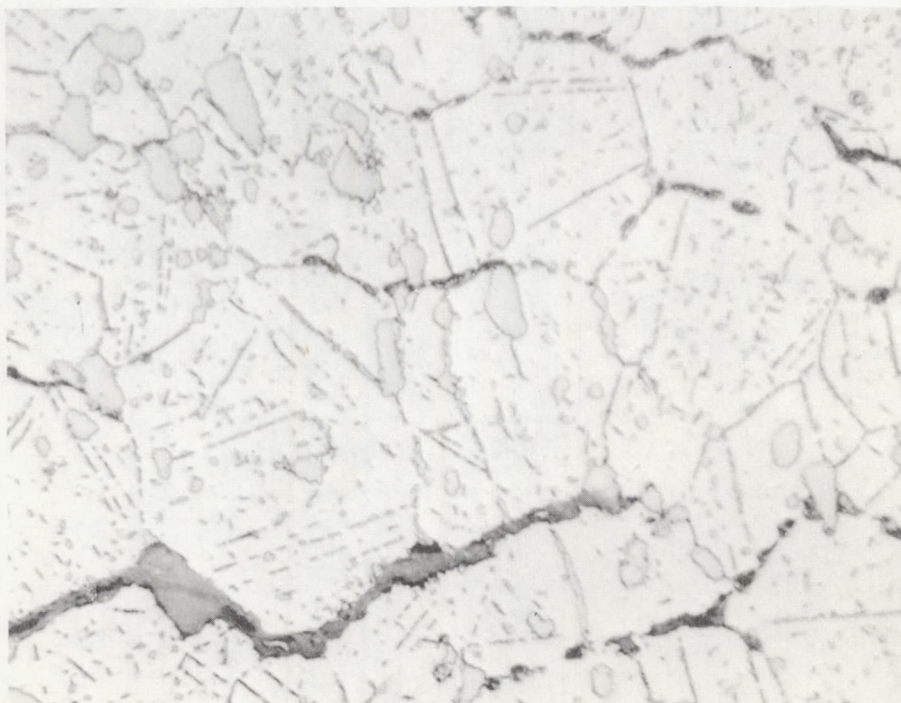
(d) Group 9, standard S-816.

Figure 8. - Concluded. Microstructures after engine test.

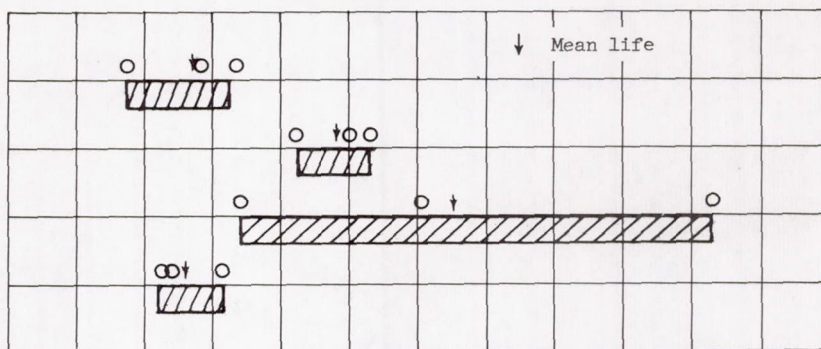
Stress-rupture results. - Stress-rupture lives of specimens cut from the airfoil of buckets of each group are shown in figure 11. All specimens were tested at 1500° F and 23,600 pounds per square inch, which are the conditions for a nominal life of 100 hours for standard S-816 alloy bar stock. Stress and temperature conditions in a range corresponding to that in buckets during the engine test were not used, since the life of specimens would have been too long. For example, at a point 2 inches above the base of the airfoil, which is in the zone where stress-rupture life of buckets is at a minimum, bucket centrifugal stress is about 10,400 pounds per square inch and bucket temperature is about 1470° F (fig. 1). Stress-rupture life at these conditions is of the order of 30,000 hours for S-816. The mean stress-rupture life of specimens from standard S-816 buckets was 94 hours, which is reasonably close to the nominal 100-hour life for bar stock. The as-overtempered groups had shorter stress-rupture lives than the standard group, with mean lives of 54 and 64 hours for groups 1 and 5, respectively. The test bars from the fully reheat-treated groups showed an improvement in life over the as-overtempered group bars; this indicated some recovery of stress-rupture properties. The mean lives of 86, 130, 94, and 88 hours are about equivalent to the standard group. The as-overtempered and

As noted in the results, the stress-rupture properties of the various groups differed appreciably. The stress-rupture life of specimens from as-overtemperated buckets and overtemperated and aged buckets was lower than that of standard-bucket specimens (fig. 11). This might be expected because overtemperature exposure can reduce stress-rupture properties of S-816 alloy, as has been shown in the laboratory and engine studies (refs. 2 and 3).

(b) Engine A. Temperature, over 1800° F (tailpipe) on acceleration.

Figure 11. - Stress-rupture results of specimens from bucket airfoils.
Stress, 23,600 pounds per square inch; temperature, 1500° F.

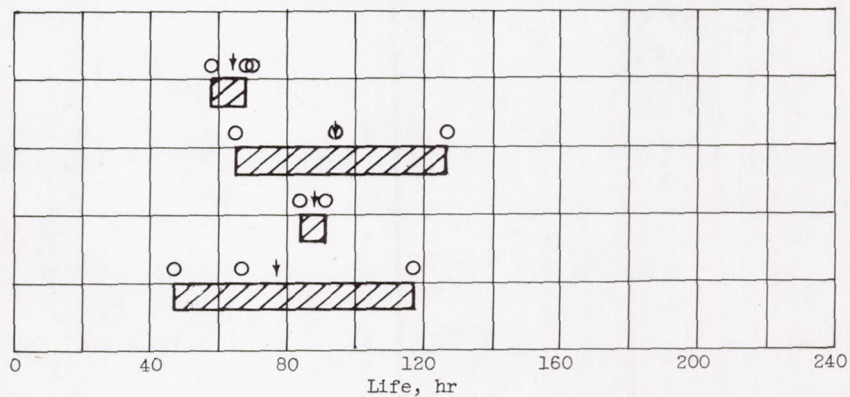
(c) Engine B. Temperature, over 1500° F (tailpipe); engine overspeed, 104 percent.
